Billet Surface Visual Inspection Device

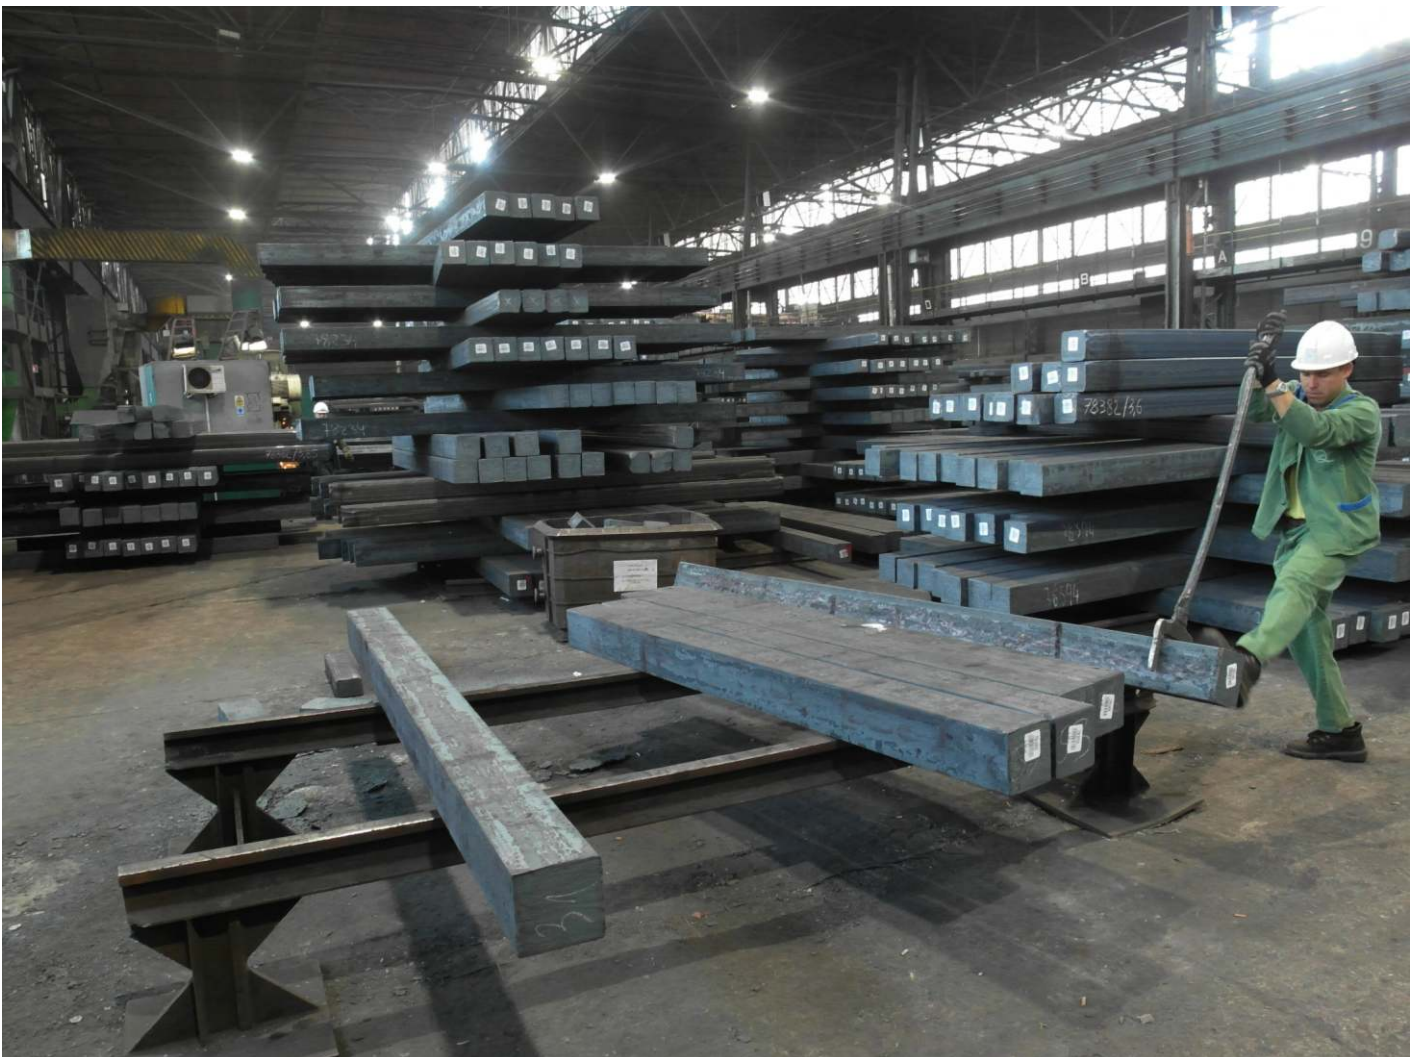
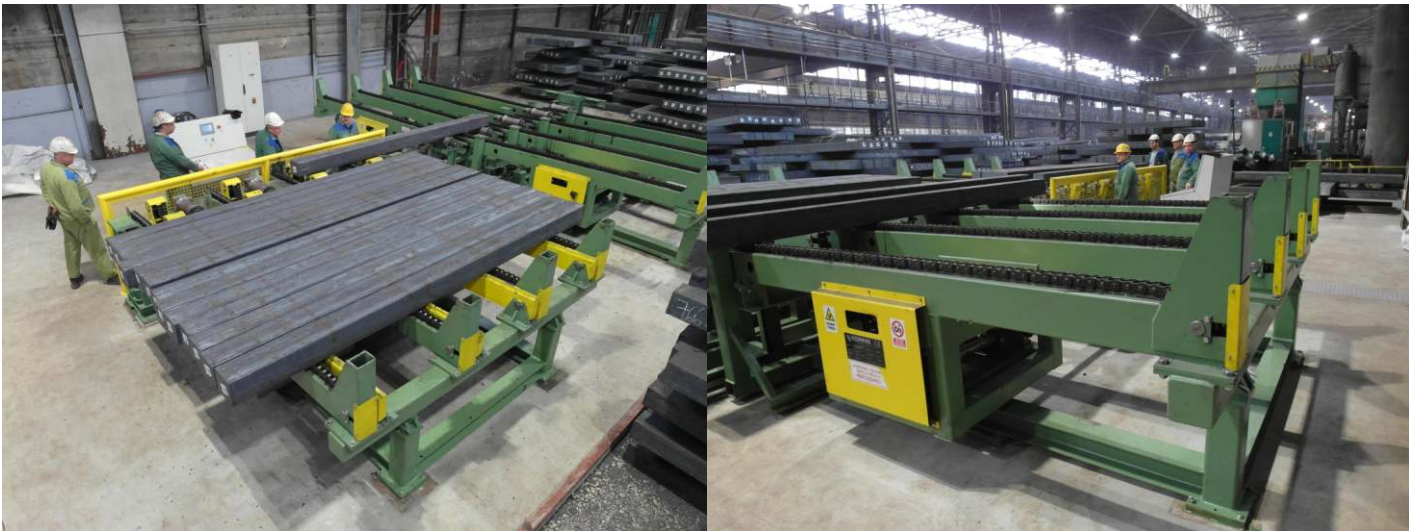
Before the new billet visual inspection device (VKG) was set, the surface of 140 mm and 180 mm square billets was inspected on, for this purpose adapted stands. To inspect the surface of billets, all the billets had to be rotated manually with a special open-end wrench to inspect all four sides.

Above: Billet surface manually inspection

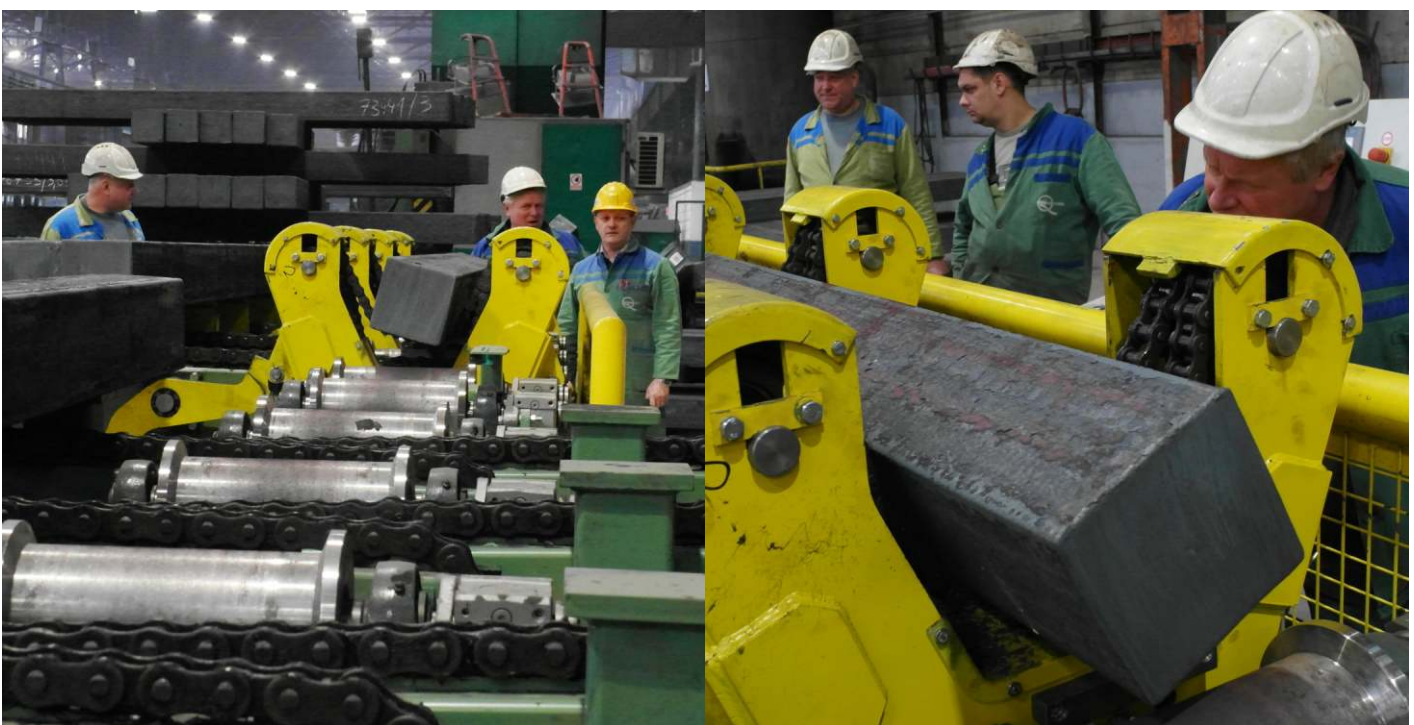
The device is manufactured to enable visual detection of surface defects on all four billet sides and automatic rejection and rotation of individual billets and sorting to specified strand. The billets are automatically sorted to good and bad ones according to results of surface inspection. The device is capable of inspecting 60 billets per hour.

Photos above: the new device testing

the A-B plant. The foundations were made in November according to the machine plans and in December 2017, the new billet visual inspection device was set, all the installations done, the device started, operators trained and the new device tested.
